Boots & Coots Regains Control of Well After Underground Blowout and Surface Broach

SUITE OF LOGGING TOOLS HELPS DETERMINE DETAILED SOURCE CONTROL RESPONSE PLAN

SOUTH AMERICA

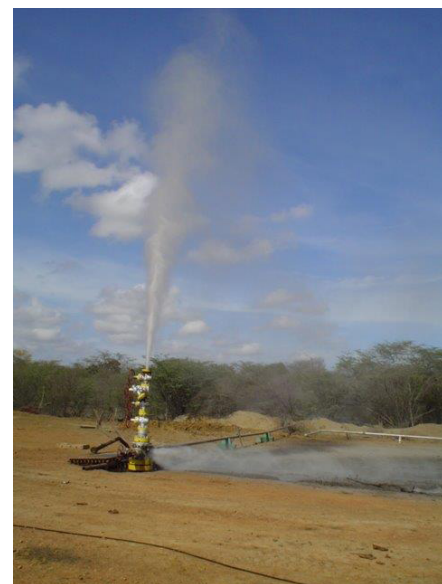
HAL64719

Prior to Boots & Coots regaining control of this well, gas flows in full open mode through the crown valve and a hole in the wellhead.

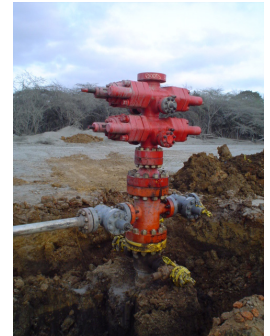
Boots & Coots installed a blowout preventer (BOP) stack on the well, and diverted gas flow to a burn pit.

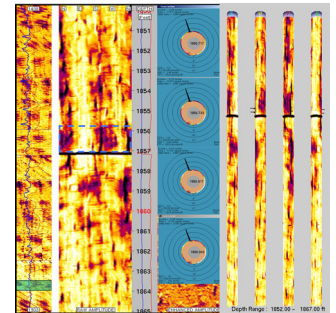
HAL64713

It was believed that the integrity of the casing in the well was compromised. A suite of logging tools (gamma ray, casing-collar locators, CAST-V™ circumferential acoustic scanning tools, cement bond logs, and variable-density logs) was run in the hole, which confirmed that severe damage was present on the production casing. The operator decided to perform well abandonment operations, basing its plan on the log data and local regulations.

CAST-V™ logs revealed multiple instances of damage in the production casing.
