Boots & Coots Safely Kills Six-Well, Single-Pad Blowout

TEAM SOLVES MAJOR WELL-CONTROL CHALLENGE NEVER SEEN BEFORE IN THE INDUSTRY

CONVERSE COUNTY, WYOMING, USA

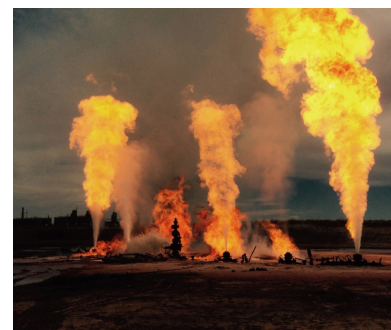
The original production trees had been installed with the casing valves aligned in series and pointing toward adjacent wells. Heat from the first well fire caused the other wellheads and valves to leak and catch fire – a cascade effect that intensified the complexity of controlling the source. The first well caught fire in the evening, and by morning all the wells were burning.

Figure 1. The six-well pad fire, with wells in close proximity and generating extreme heat, was the first blowout of its kind in the industry.

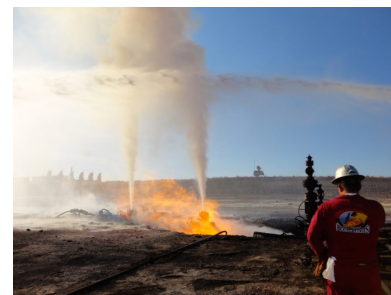
The main safety challenge was managing both direct and radiant heat. The crossfire from the failed side valves generated unpredictable fire behavior around the pad, creating hazards for approaching the wells and further complicating source control efforts.

Figure 2. The fires of three proximate wells feed each other to create a complex fire hazard on the site. The side valve of the well on the right is compromised and is feeding a mixture of gas and condensate to the other two wells.

By Day 16, all the wells were under control, with the damaged wellheads removed and the wells re-headed. The principal lesson learned from this incident is the need to configure production trees so all valves are perpendicular to the direction of the pad and face away from other wells.

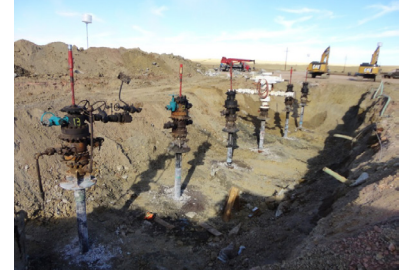
Figure 3. After all the wells were safely capped, the pad was excavated to install new wellheads.

One of the wells was severely damaged with a visible condensate leak, and another had developed a minor leak below the tubing hanger. After completing risk analysis, the team decided to plug these two wells with cement. By Day 16, all the wells were under control, with the damaged wellheads removed and the wells re-headed.
