Boots & Coots Regains Control of Well After Underground Blowout and Surface Broach

SUITE OF LOGGING TOOLS HELPS DETERMINE DETAILED SOURCE CONTROL RESPONSE PLAN

SOUTH AMERICA

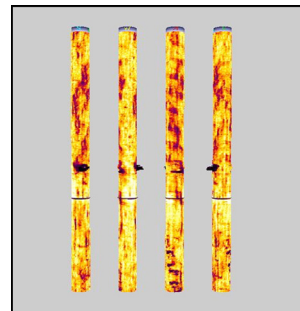
HAL64718

After the well had been killed, the remainder of the production tubing was recovered. Observation at the surface indicated several holes and severe corrosion damage to the tubing.

The snubbing unit found multiple instances of corrosion damage in the production tubing that it recovered.

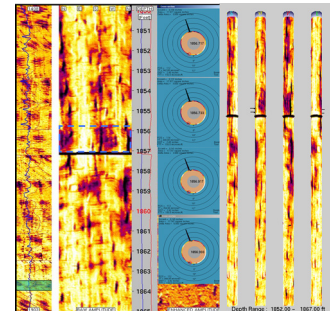
HAL64713

It was believed that the integrity of the casing in the well was compromised. A suite of logging tools (gamma ray, casing-collar locators, CAST-V™ circumferential acoustic scanning tools, cement bond logs, and variable-density logs) was run in the hole, which confirmed that severe damage was present on the production casing. The operator decided to perform well abandonment operations, basing its plan on the log data and local regulations.

CAST-V™ logs revealed multiple instances of damage in the production casing.
