Boots & Coots Safely Kills Six-Well, Single-Pad Blowout

TEAM SOLVES MAJOR WELL-CONTROL CHALLENGE NEVER SEEN BEFORE IN THE INDUSTRY

CONVERSE COUNTY, WYOMING, USA

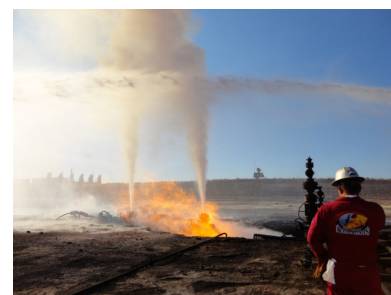
The main safety challenge was managing both direct and radiant heat. The crossfire from the failed side valves generated unpredictable fire behavior around the pad, creating hazards for approaching the wells and further complicating source control efforts.

Figure 2. The fires of three proximate wells feed each other to create a complex fire hazard on the site. The side valve of the well on the right is compromised and is feeding a mixture of gas and condensate to the other two wells.

By Day 16, all the wells were under control, with the damaged wellheads removed and the wells re-headed. The principal lesson learned from this incident is the need to configure production trees so all valves are perpendicular to the direction of the pad and face away from other wells.

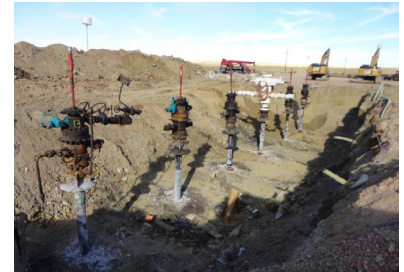
Figure 3. After all the wells were safely capped, the pad was excavated to install new wellheads.

One of the wells was severely damaged with a visible condensate leak, and another had developed a minor leak below the tubing hanger. After completing risk analysis, the team decided to plug these two wells with cement. By Day 16, all the wells were under control, with the damaged wellheads removed and the wells re-headed.
