# Operator Identifies Shallow Surface-Casing Corrosion Without Costly Workover

HALLIBURTON ELECTROMAGNETIC PIPE XAMINER® V (EPX™V) TOOL DETECTS METAL LOSS NEAR WELLHEAD

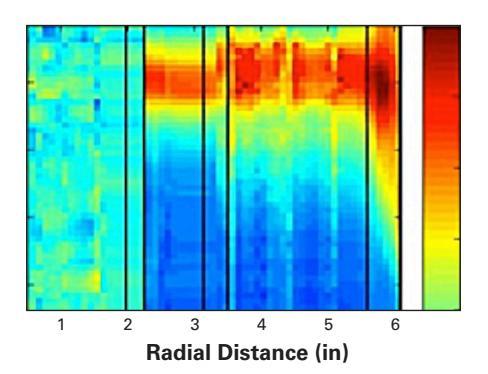
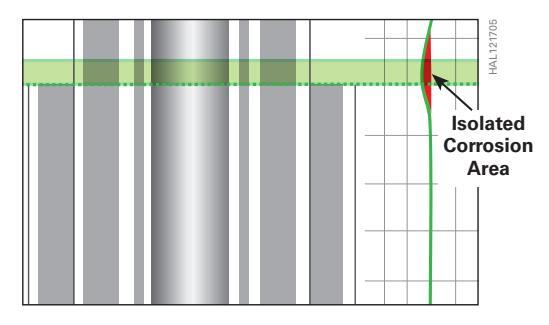
The section of the well in question was logged, and the results indicated a shallow metal loss anomaly within a few feet of the surface-casing hanger. Subsequent surface diagnostics were performed, which indicated a shallow location. The operator cut windows into the conductor casing and positively verified the location and degree of the corrosion.

Since the leak was identified near surface, a rigless external casing repair was performed, saving the cost and avoiding the risk associated with using a rig to cut and pull multiple strings of pipe.
