# Boots & Coots Regains Control of Platform After Five-Well Blowout

## TEAM MAINTAINS STABILITY OF 30-WELL PLATFORM, CONTAINS BLOWOUTS, AND SAFELY CAPS WELLS

CASPIAN SEA

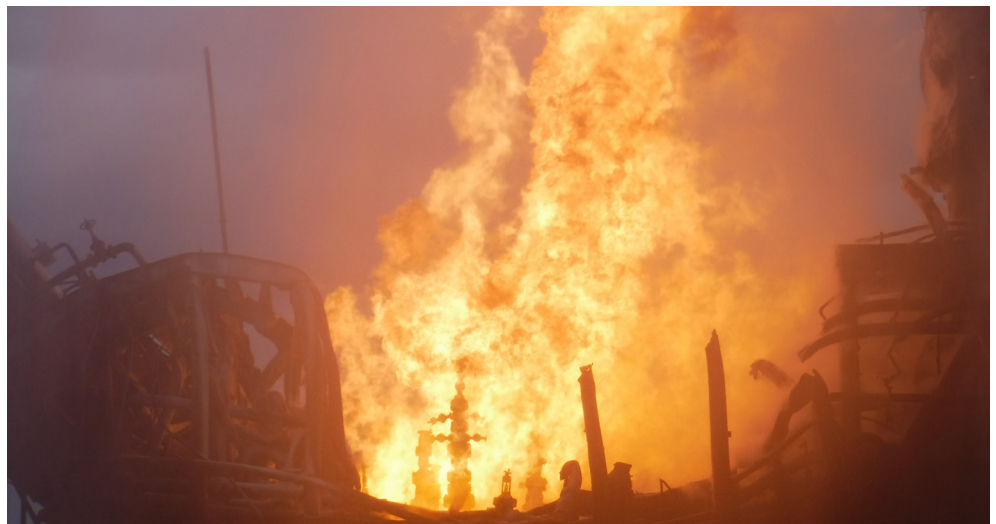
Fire erupts on an offshore production platform in the Caspian Sea, where an explosion in a gas pipeline caused a fire that triggered multiple wells to develop leaks and blowouts.

In the Caspian Sea, storm damage to a gas transmission pipeline on a 30-well production platform caused an explosion; the resulting fire damaged five wellheads (four producing gas and one producing oil), which triggered blowouts as escaping gases ignited. Consequently, the heat from the blowouts damaged several adjacent wells, causing additional leaks to develop. The operator contacted Boots & Coots, which responded immediately, mobilizing well control experts to lead the efforts to safely contain the situation.

With the protocols developed, the well control team could begin the source control operation consisting of the following steps: ensure a reliable and continuous deluge system, complete debris removal, commence jet cutting operations, and complete the well capping and kill operations.

Firefighting boats were mobilized to spray water onto the platform to reduce heat damage to the platform and neighboring wellheads. In conjunction, a water deluge system was installed on the platform to provide a continuous water curtain. Two submersible pumps provided a reliable feed to the firefighting pumps that would not be affected by adverse weather conditions.

Debris removal provided safer access routes to the wellheads. The operation involved removing damaged parts and building temporary working platforms from which to reach more inaccessible areas. Once safe access had been established to the blowout wells, three wellheads were cut using an abrasive jet cutter that allowed the plumes to be directed vertically, thus eliminating crossfire from leak points on the wellheads, and significantly reducing the risk to the platform.

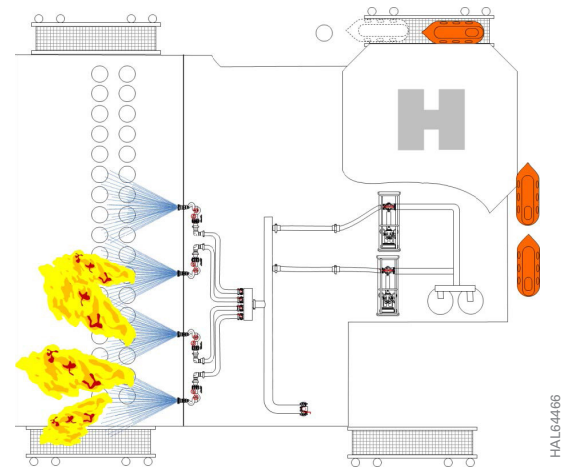
*A plan view of the platform illustrating the heat damage mitigation; a reliable deluge system provided an around-the-clock water curtain, regardless of weather conditions.*

The deluge system proved to be a very effective and reliable method of significantly reducing heat damage. The source control operation was completed in 64 days, 25 of which were nonproductive due to poor weather conditions. The job was performed safely without any injuries.

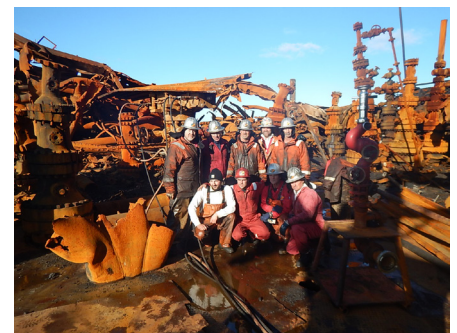
*The Boots & Coots well control team poses in the damaged well bay after the wells had been safely capped and all leaks were stopped.*

While debris removal was underway, the operator’s well control team assisted Boots & Coots by pumping kill fluid into wells in the unaffected area and, in so doing, secured these wells. Several adjacent wellheads showed various degrees of damage and, as soon as access to the wellheads was gained, they were replaced, eliminating the risk of unexpected flow or the risk of the well catching fire.
