# Boots & Coots Mobilizes WELLSURE® Blowout Response Process After Client's Well Suffers Major Blowout

## WELL CONTROL SPECIALISTS SUCCESSFULLY KILL WELL, SAVING OPERATOR MILLIONS OF DOLLARS

NEAR WAYNESBORO, MISSISSIPPI

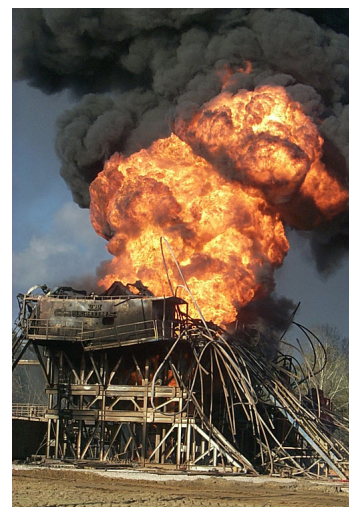
While pressure increased, rig personnel attempted to install a 4.5-inch liner x 3.5-inch drillpipe crossover sub, so that the liner could be lowered and the 3.5-inch pipe rams closed. While performing this task, the casing slips unseated at the rotary table and a total of 11 joints of 4.5-inch liner blew back out of the well. The 11 joints of liner became wedged into the rig derrick structure.

In a final effort to control the well, the blind rams were closed in on the 4.5-inch production liner, crimping the liner but failing to stop the blowout. After the mud evacuated the hole, the well began to eject gas that contained more than 25 percent of hydrogen sulfide (H<sub>2</sub>S) per volume; the gas was ignited in order to burn off the H<sub>2</sub>S escaping the well.

After a blowout, the damaged drilling rig is on fire.

After arriving on location, Boots & Coots' well control specialists set up hazard zones, and began the measured and methodical process of debris clearance, including the removal of the drilling rig, which had begun to collapse over the well. Due to the presence of H<sub>2</sub>S,

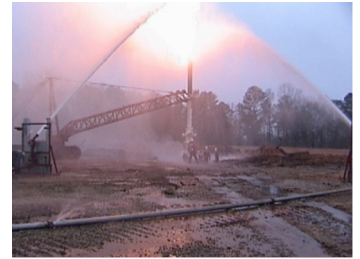
Due to casing and wellhead damage and the high pressures involved, the blowout could not be shut in and a diverter system was necessary. In addition, the presence of H<sub>2</sub>S required the well to be capped while still ignited.

*The blowout well is capped, and a Venturi tube and diverter system are in place.*

A capping stack with a Venturi tube and diverter system was maneuvered onto the well, and diverter lines were installed to direct the hydrocarbons to burn pits. Once the well was under control, evacuated residents were allowed to return to their homes.
