Operator Implements Innovative Biocide Treatment to Eradicate Acid Producing Bacteria in Frac Water

COMBINATION MULTI-CHEM BIOCIDES SYSTEM USED TO COST-EFFECTIVELY SAVE 650,000 GALLONS OF WATER FOR RE-USE

LOCATION: WHEELER, TX, UNITED STATES

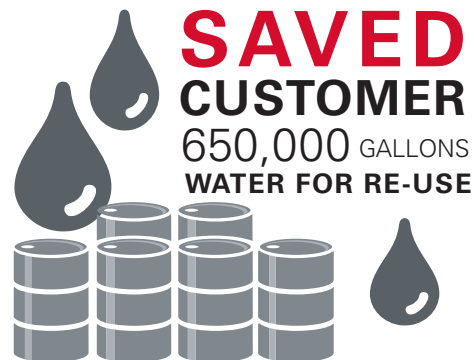
Multi-Chem executed a planned operation which included bacterial testing to determine effectiveness immediately after treatment. First, water trucks were used to roll each tank to ensure proper distribution of the biocide mixture. B-8510 was then slurried into fresh water to keep the material properly distributed in the pre-frac blender water tanks before pumping. Finally, monitoring after the single treatment indicated that all signs of bacteria were removed from the water tanks. Overall, the entire operation took only three hours and involved only two people, reducing both the time to treat relative to alternatives, and reducing the overall cost.

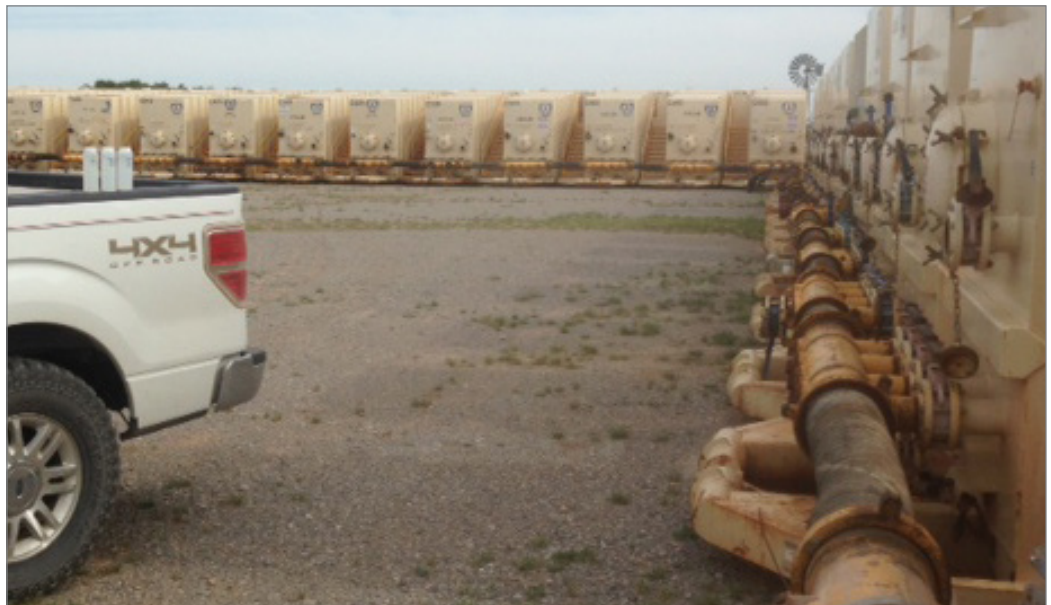
With a cost-effective biocide, Multi-Chem successfully treated 31 frac tanks that were contaminated with acid producing bacteria, saving the operator 650,000 gallons of water.
