Intercept® Retrievable Bridge Plug is Successfully Installed and Then Retrieved After Nine Months in Wellbore

HALLIBURTON RETRIEVABLE BRIDGE PLUG PROVIDES GAS-TIGHT, V0-GRADE BARRIER

NORWAY

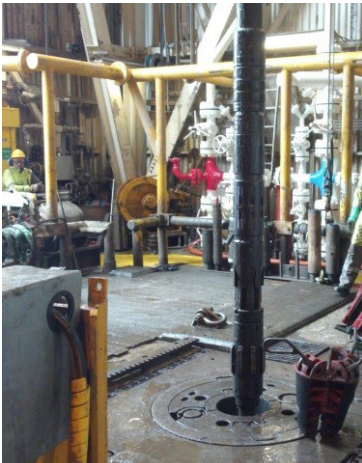
Removing the Intercept® bridge plug nine months after installation

The retrieval of the 9 5/8-in. Intercept RBP went according to plan with no issues and zero non-productive time (NPT). Effective communication between offshore and onshore personnel, along with the successful retrieval operation, demonstrated how simple the Intercept RBP is to operate. Additionally, when the Halliburton team pulled the Intercept RBP out of hole, the tool looked brand new with no sign of damage on key parts such as the elements, slips, and ball valve module – thus further proving the durability of this tool.
