Operator Identifies Fractures and Optimizes Completion Design

PIXSTAR™ HIGH-RESOLUTION ULTRASONIC IMAGING SERVICE ENHANCES RESERVOIR UNDERSTANDING IN OIL-BASED MUD

MIDDLE EAST

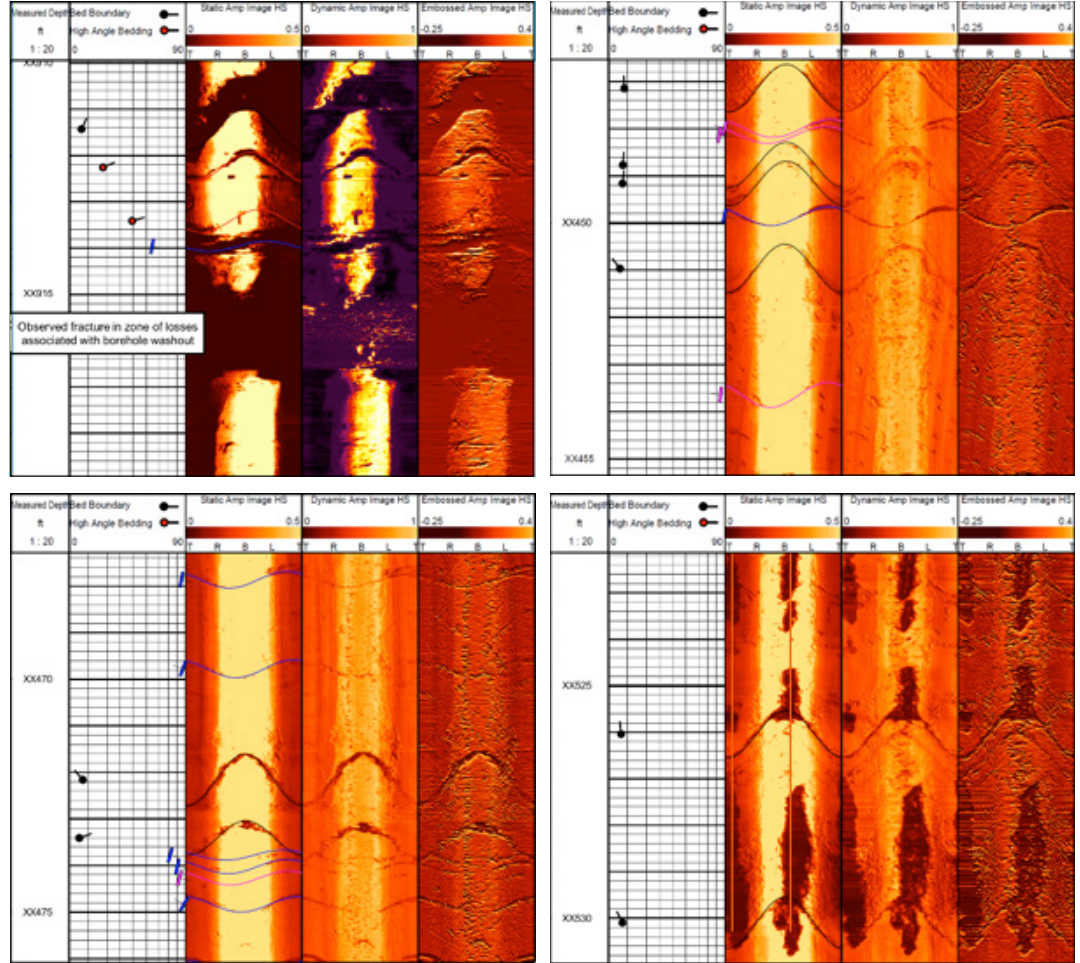
Log examples showing high-resolution ultrasonic image interpretations. The top left image shows the fracture interpreted as being associated with the mud loss zone. The three other images show fracture and bedding plane interpretations, including dip and strike calculations. The interpreted bed dips are consistent with the known field structure. The bottom right image illustrates bedding picks with borehole breakouts. Note that the breakouts appear to terminate at the bed boundaries.

Upon completion of the well, the memory data was analyzed, and the 256-sector acoustic impedance images from the PixStar service were used to assess borehole fractures and geological features. The images provided a clear indication of fractures and borehole enlargement over the zone where the mud losses were observed. The interpreted bed dips from the images were consistent with the known field structure.
