# Avenger® MLE Protects Pump Life in Corrosive, High-Temperature Life Test Conditions

## RELIABLE NEW DESIGN FOR MOTOR LEAD EXTENSIONS (MLE)

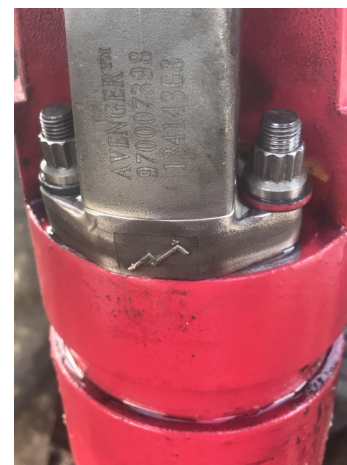
Avenger® » next generation motor lead extension.

Summit ESP® Avenger® MLE for increased reliability in high-temperature, highly corrosive gassy wells. The patented design within the Avenger MLE has a low profile, flat cable pigtail design that is spliced to the lower end of the main power cable. The design reduces rubber in the seal by 90 percent and uses an O-ring within the motor head to protect the seal. Its tape-in connection creates a 260 percent longer arc path than typical in the industry.
