# Boots & Coots Successfully Kills Leaking Well in Remote Field

## TEAM SOLVES CHALLENGING LOGISTICS TO STOP GAS LEAK PRIOR TO WELL ABANDONMENT

LOS MONOS FIELD, BOLIVIA

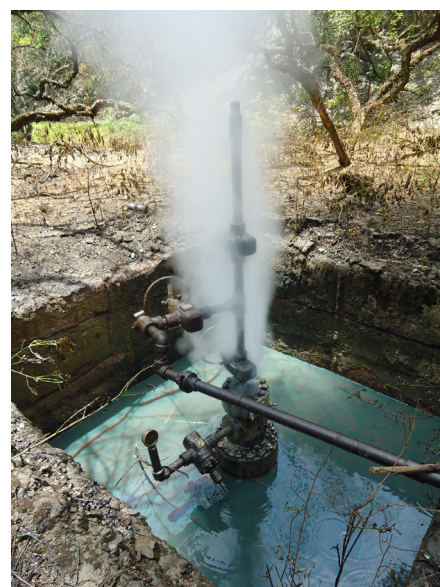
*The remote well was leaking through the wellhead via the short string of a dual completion.*

Once all the required equipment had arrived on site, it was laid out in a safe distance away from the gas leak. As a standard precaution, the air quality was measured continuously. The leak was eventually discovered to be through the short string of the dual completion, and Boots & Coots engineers designed a stinger to fit into the string in order to be able to pump the kill fluid. Subsequently, the gantry extension that held the stinger string was supported by a bulldozer, enabling it to be placed a safe distance from the wellhead. A water supply was sourced and a deluge system was installed around the location as a safety precaution to protect personnel and equipment during the kill operation.

Once the Boots & Coots well control specialists maneuvered the stinger over the leaking completion string and safely connected it to the top of the completion y-block, they were able to pump kill fluid into the well. It took approximately 240 bbl of kill fluid to control the well and to stop the leak by displacing the gas out of the well. Once control of the well had been successfully regained, a new wellhead was installed prior to well abandonment operations.

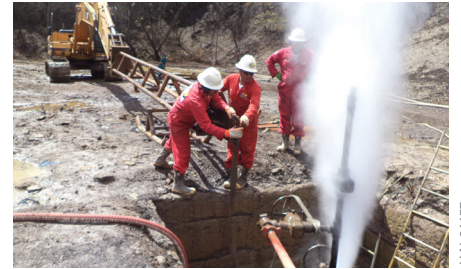
*Prior to killing the leaking well, the Boots & Coots team had to first regain control of the well.*

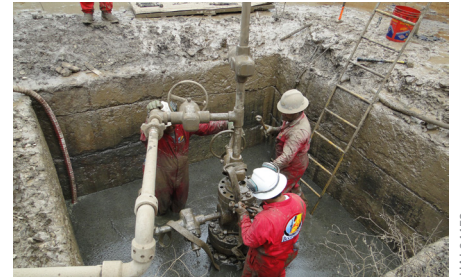
*After regaining control of the well, the Boots & Coots team installed a new wellhead.*
